# Home Inspection Report

Van Nuys, CA

**Inspection Date:**  
April 12, 2010

**Report Number:**  
41210

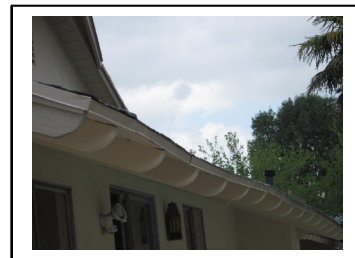
- **Improve:** The ridge caps are worn and should be replaced.
- **Repair:** There is a section of roof shingles that is puckered On the overhang at the rear

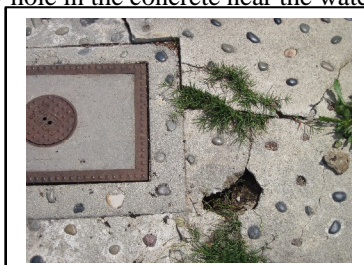
- **Repair:** The gate and/or latch mechanism needs adjustment to function properly.
- Repair:** There is a new hole in the concrete near the water main, possible leak in that area.

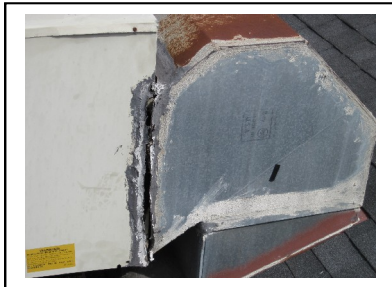
**Major Concern:** The heating system is inoperable, it may be wiser to replace the system than repair it.

**Improve:** There is an area where the ducting is separating from the FAU

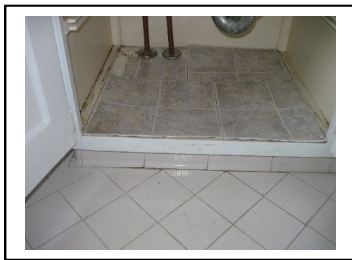
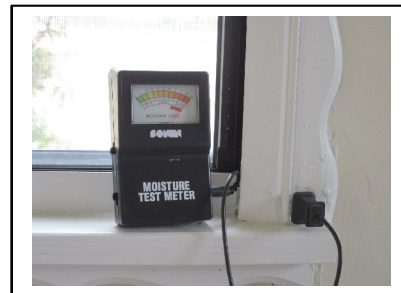
**Safety Issue:** Large non tempered glass windows are very dangerous.

**Improve:** Most window screens are missing.

**Repair:** The sliding glass door latch needs repair or replacement

**Improve:** There is an area on the window frame in the back bedroom that is stained and the wood is moist

**Improve:** The bath cabinet is warped at the base, water damage from leaking drainage pipes.
